## **Spatio-Temporal Patterns of Geomorphic Adjustment in Channelized Tributary Streams of the Lower Hatchie River Basin, West Tennessee**

Mary A. Boulton  
*University of Tennessee - Knoxville*

Boulton, Mary A., "Spatio-Temporal Patterns of Geomorphic Adjustment in Channelized Tributary Streams of the Lower Hatchie River Basin, West Tennessee. " PhD diss., University of Tennessee, 2005.  
[https://trace.tennessee.edu/utk\\_graddiss/668](https://trace.tennessee.edu/utk_graddiss/668)

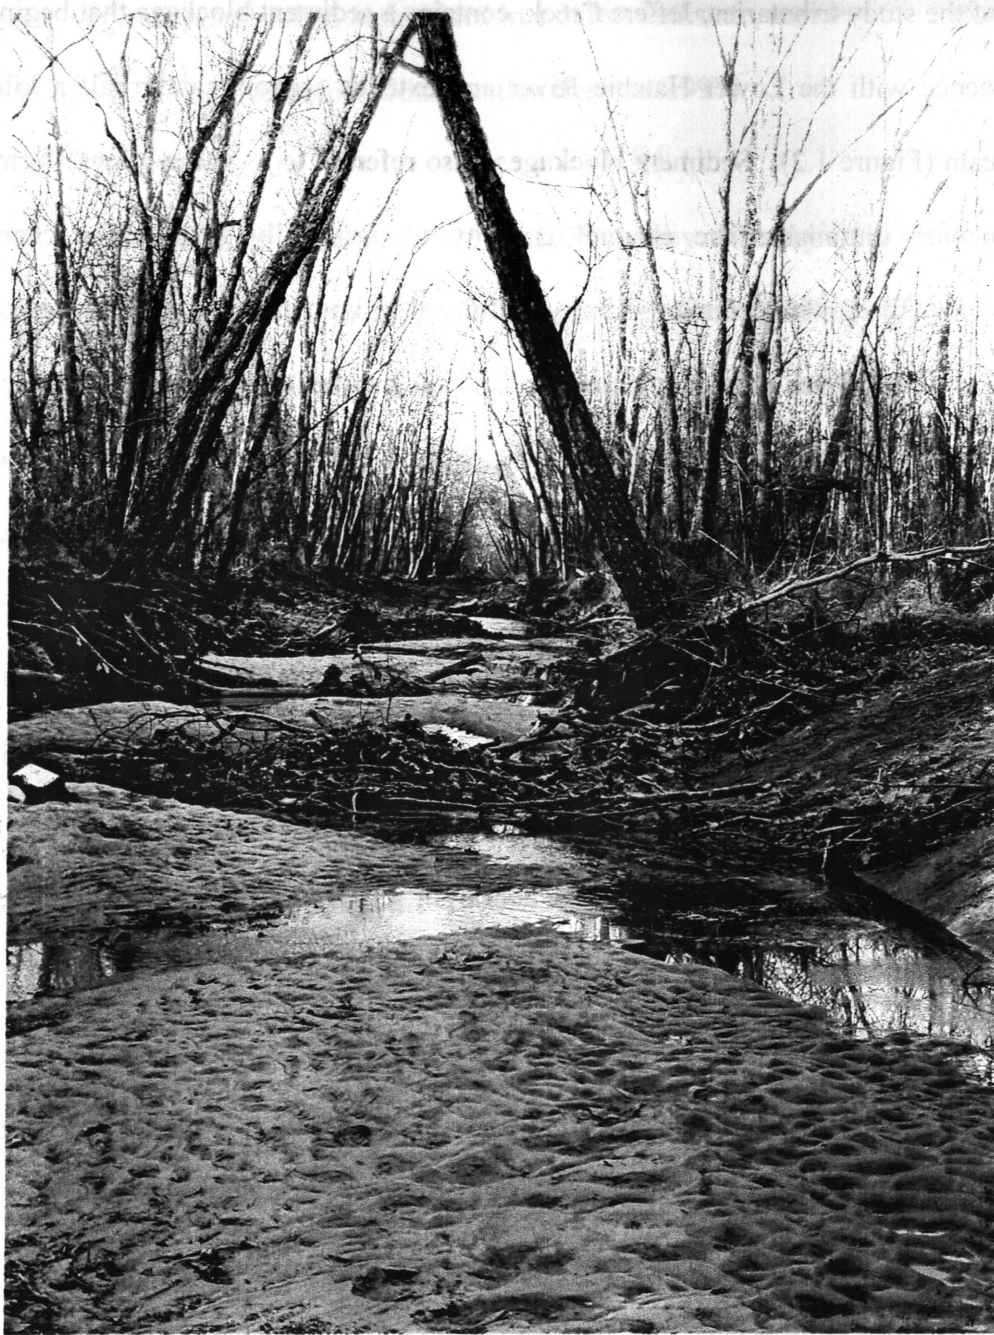
**Figure 1.2:** Starting point of sediment blockage located at mouth of Jeffers Creek downstream of Bachelor Levee Road.

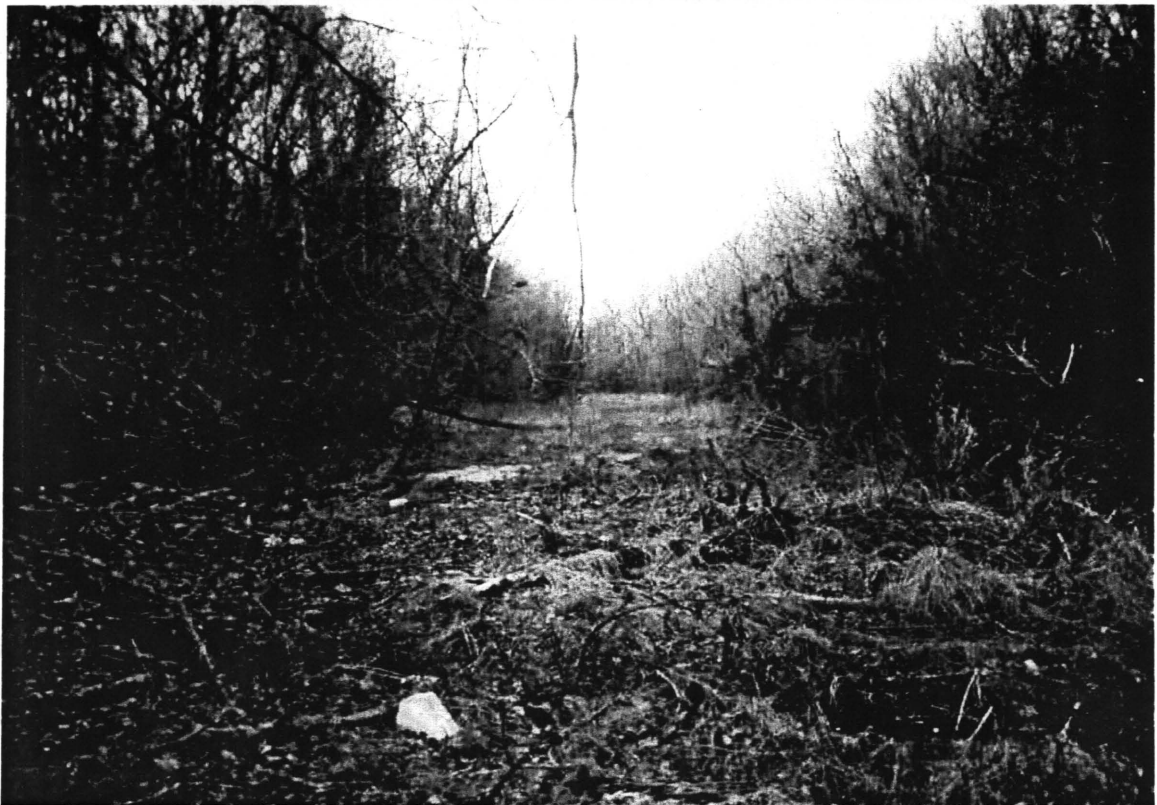
**Figure 1.3:** Channel completely filled by sediment blockage on Hickory Creek.

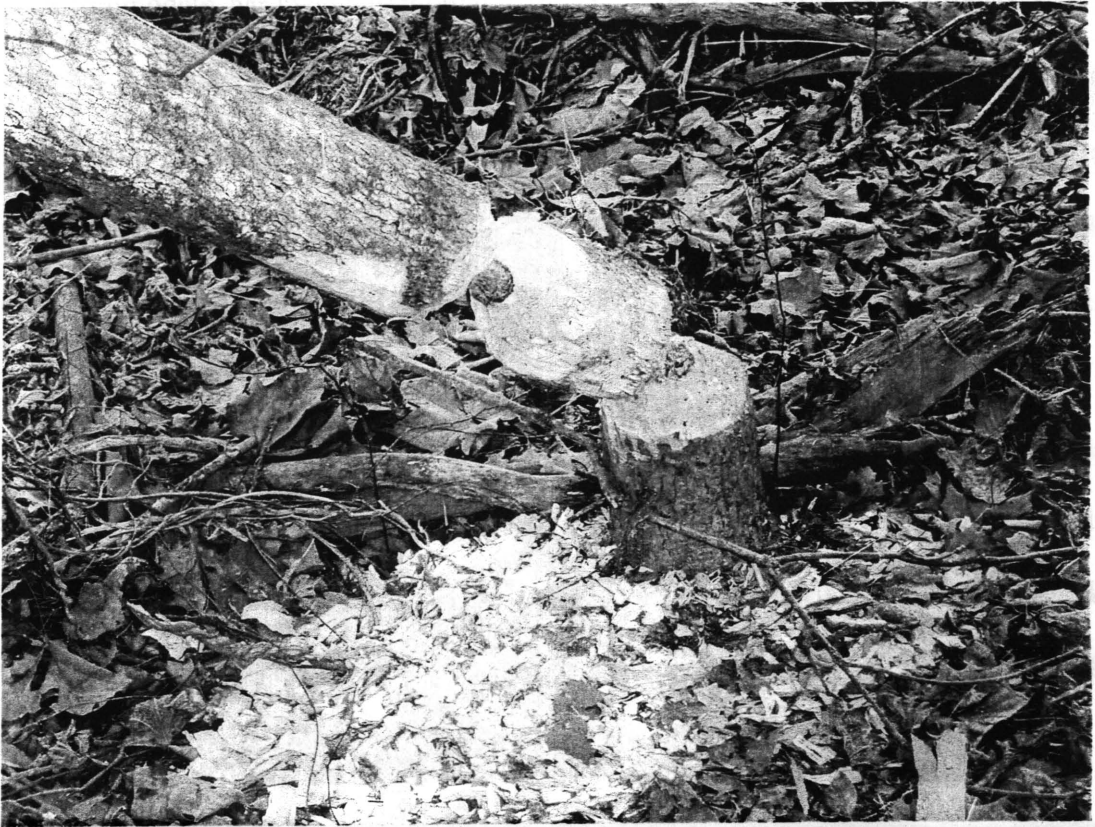
**Figure 1.4:** Evidence of beaver activity adjacent to sediment blockage downstream of Bachelor Levee Road in Jeffers Creek.

The sediment blockage located at the mouth of Jeffers Creek has resulted in the development of a seasonally flooded bottomland that is progressively developing into a full-fledged wetland. Although accelerated aggradation appears to be involved in the formation of the blockage and seasonally flooded bottomland, the formation and/or maintenance of the seasonally flooded bottomland is also probably related to beaver damming that occurs in the river segment (Figures 1.4 and 1.5). The seasonally flooded

The sediment blockage located at the mouth of Jeffers Creek has resulted in the development of a seasonally flooded bottomland that is progressively developing into a full-time wetland. Although accelerated aggradation appears to be involved in the formation of the blockage and seasonally flooded bottomland, the formation and/or maintenance of the seasonally flooded bottomland is also probably related to beaver engineering that occurs in the river segment (Figures 1.4 and 1.5). The seasonally flooded

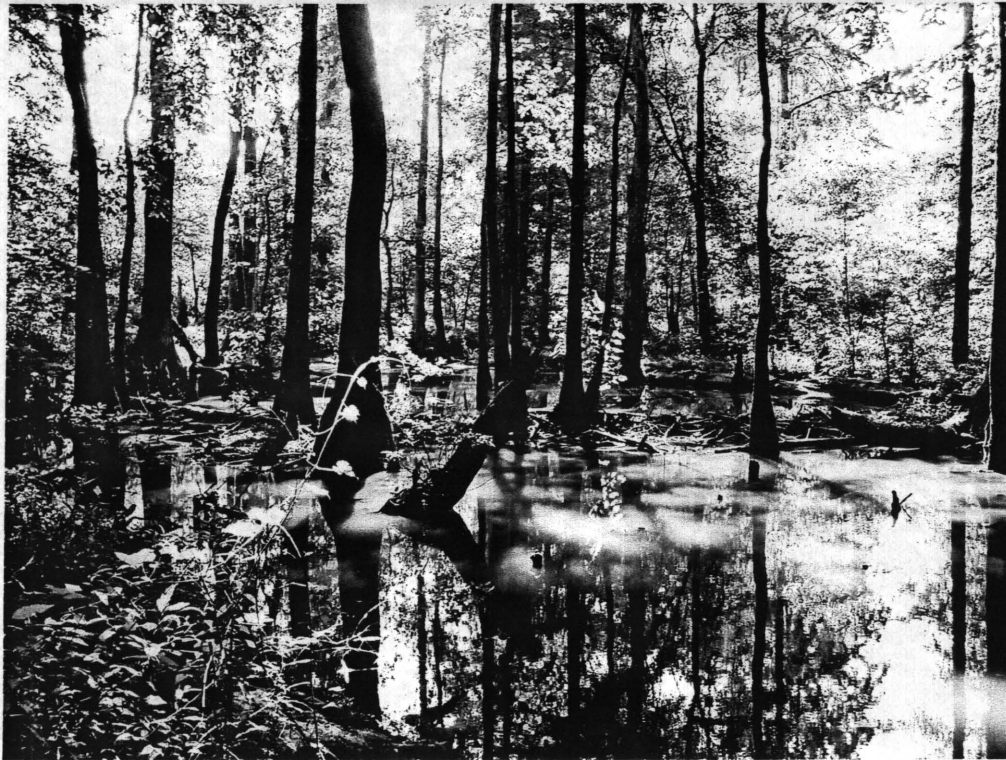
**Figure 1.5:** Evidence of beaver activity, located near confluence of Jeffers Creek and Lower Hatchie River, upstream of Eustonale Road.

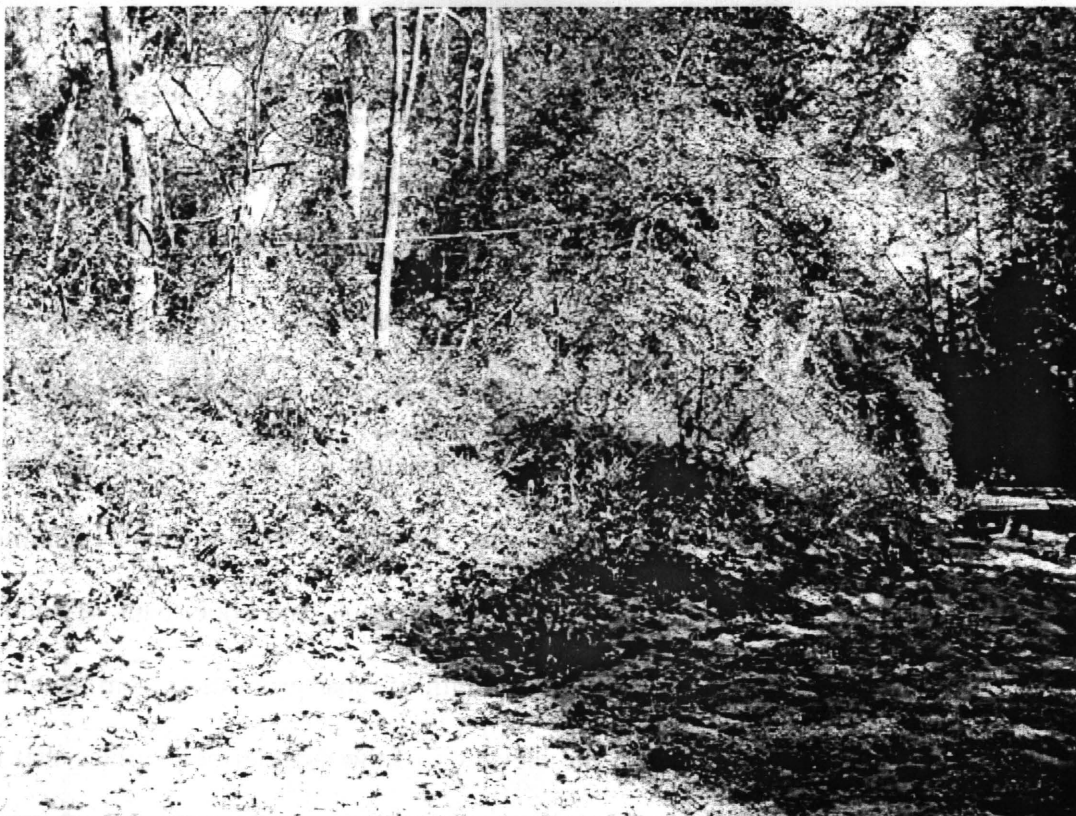
**Figure 4.2:** Photograph of reach R2 showing sediment storage berm on left bank.

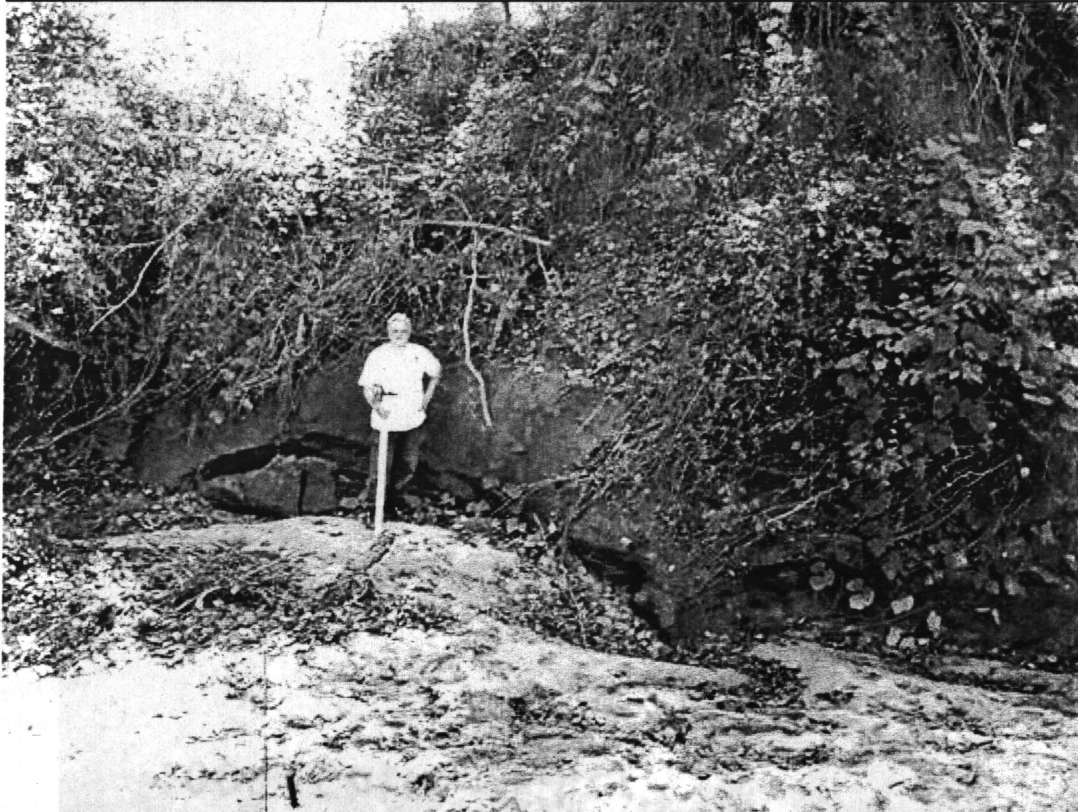
**Figure 4.3:** Photograph of reach R2 showing bank failure affecting right bank.

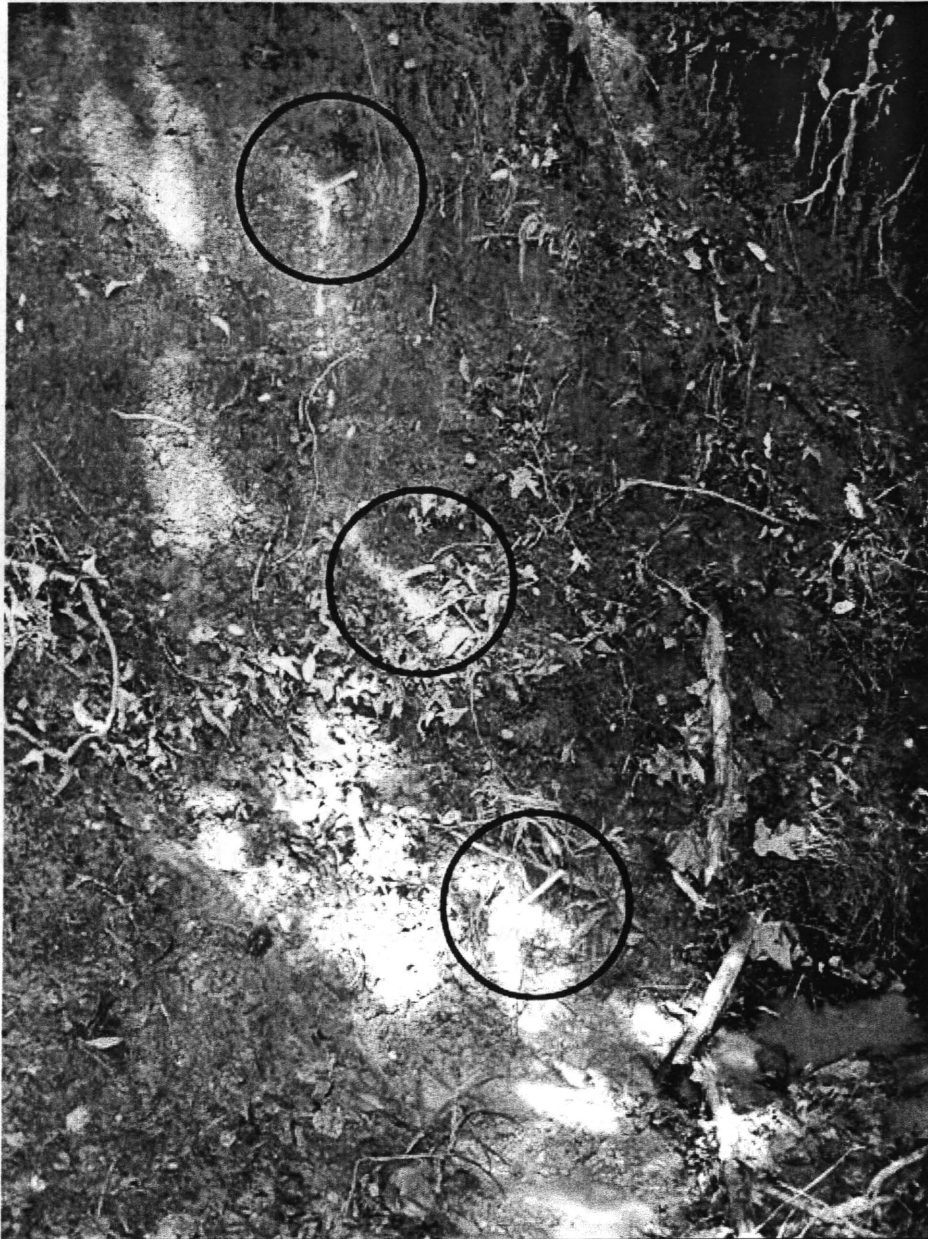
**Figure 4.4:** Example of bank erosion rebar deployment in Richland Creek, with rebar indicated by circles.

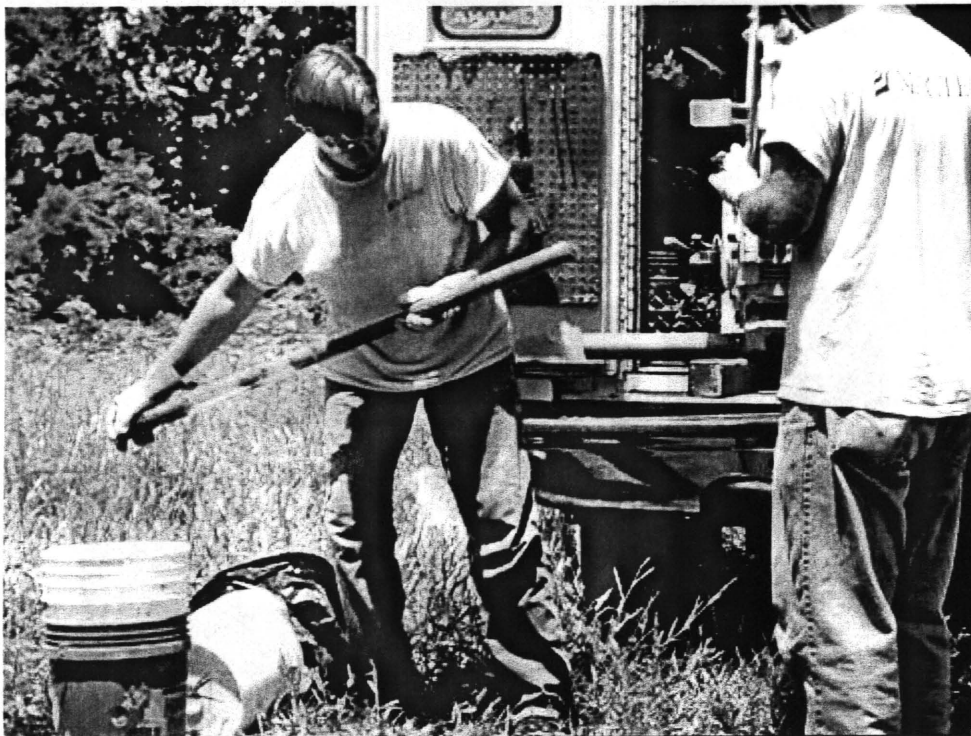
**Figure 4.7:** Sediment core plastic tube after extraction from metal casing by Mactec personnel.
